## **FINAL REPORT**

### **Development of Improved Procedures for Managing Pavement Markings During FDOT Highway Construction Projects**

**July 2003**

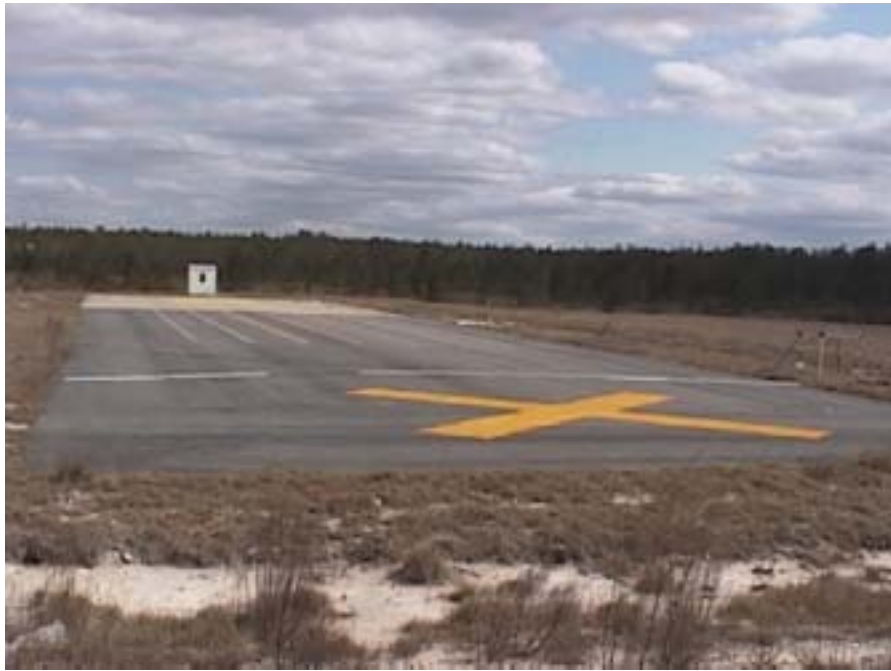
Figure 3-2. The Camp Blanding Test Site

The photos of the Camp Blanding, SR 121, and SR 26 highway work zone test sites are shown in Figure 3-2, Figure 3-3, and Figure 3-4 respectively.

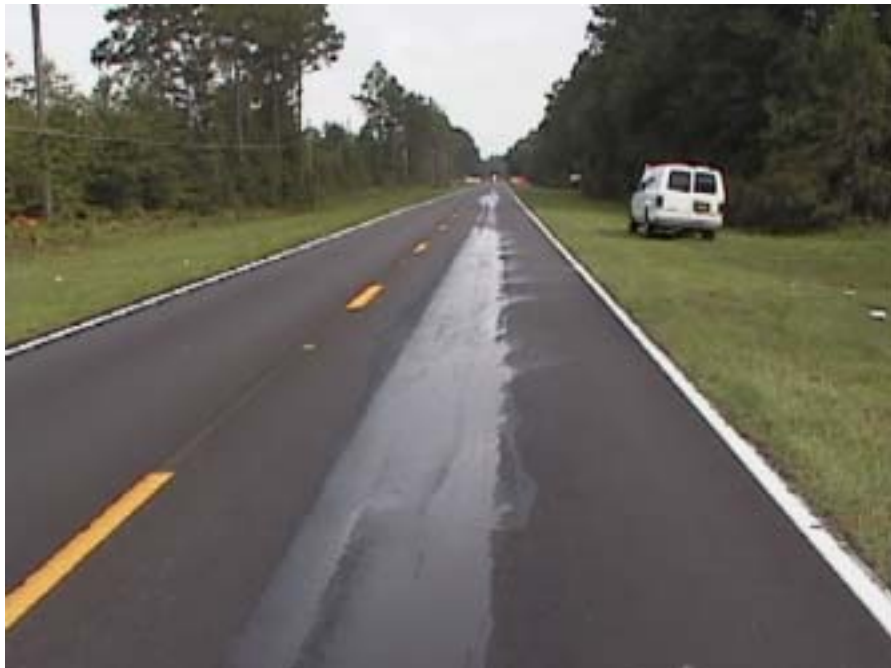
Figure 3-3. The SR 121 Test Site

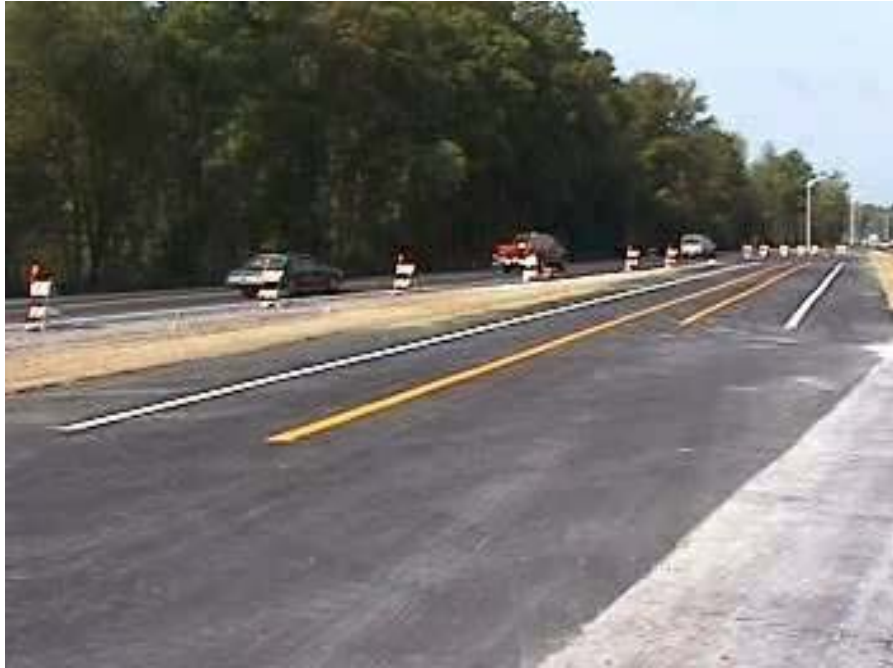
Figure 3-4. The SR 26 Test Site

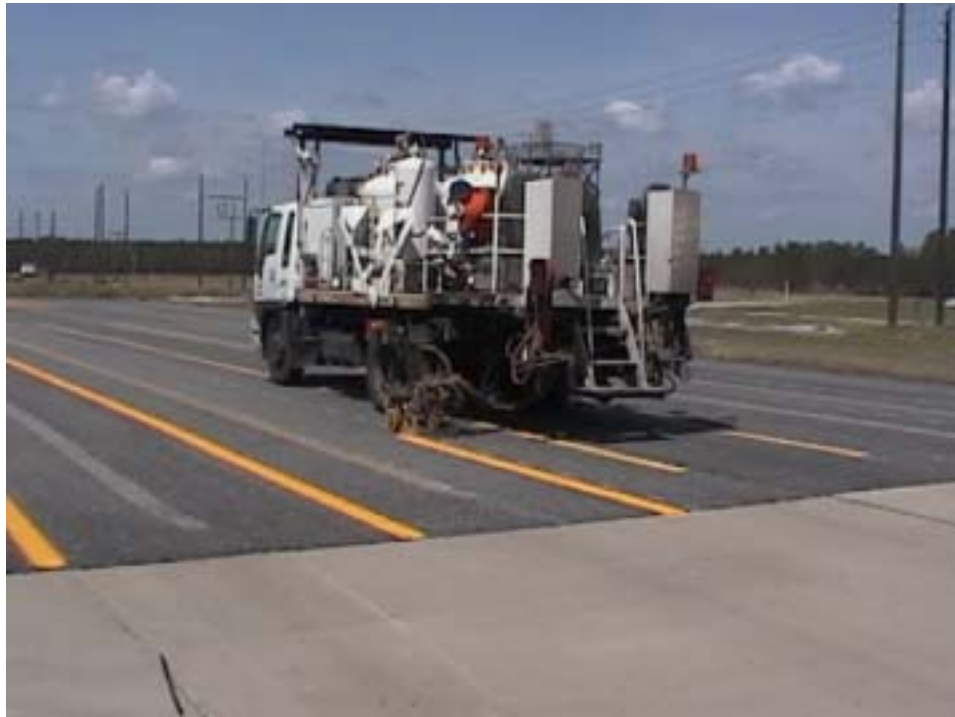
Figure 3-4. Application of Paint Marking Strips at Camp Blanding

Paint marking strips was applied for the test at Camp Blanding (see Figure 3-4). Hand spray application was used for the Camp Blanding test sites and hand rubber squeegee application was used for the SR 121 test site in this study. Photos of seal coat application with hand spray at Camp Blanding and the result with two-coat application at Camp Blanding are shown in Figure 3-5 and in Figure 3-6 respectively.

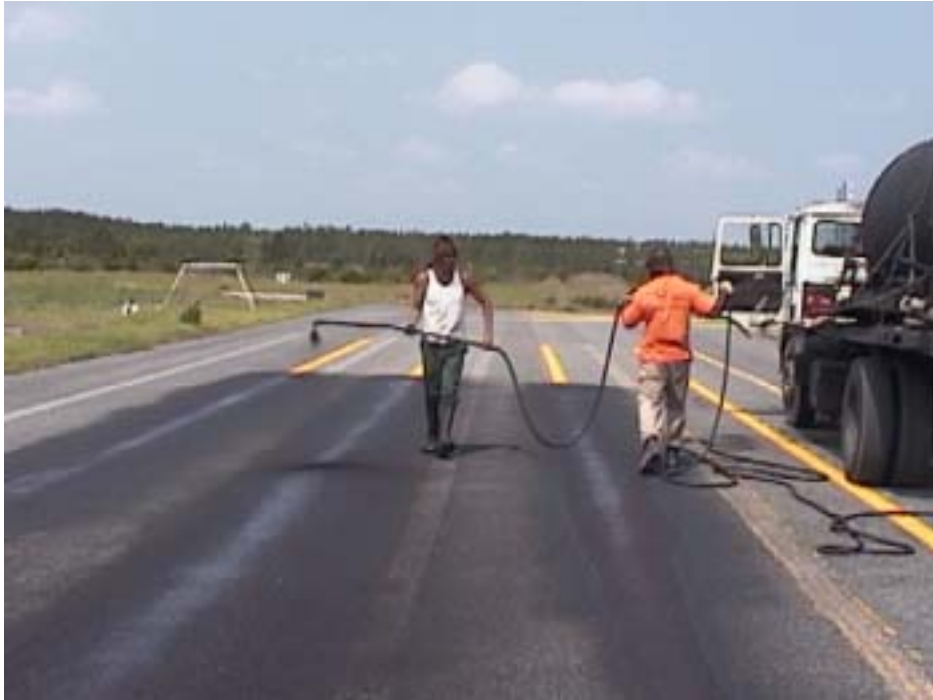
Figure 3-5. Application of Seal Coating with Hand Spray at Camp Blanding

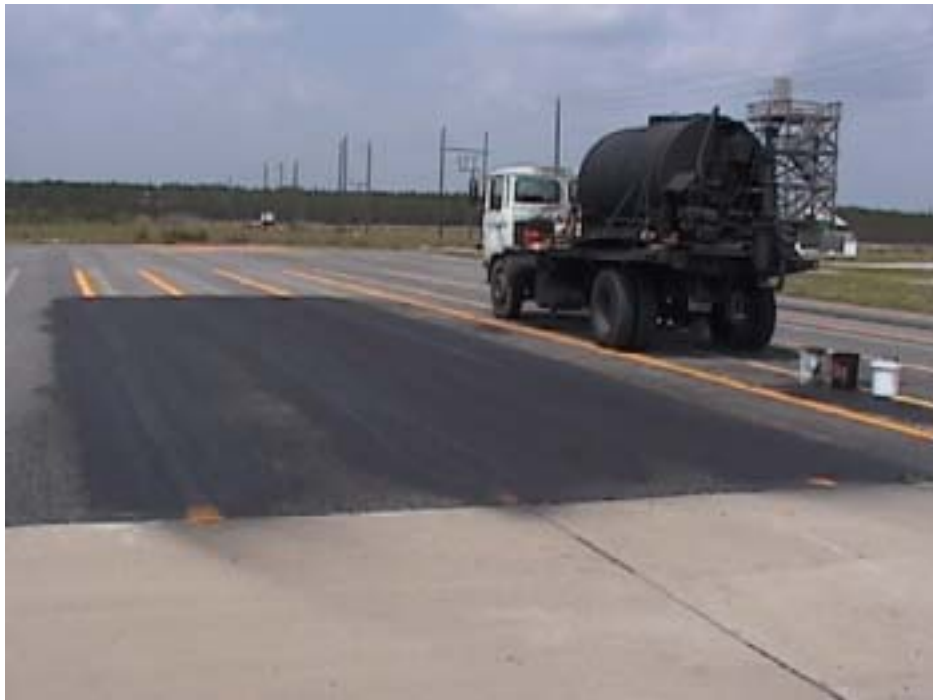
Figure 3-6. Result with Two-Coat Application at Camp Blanding

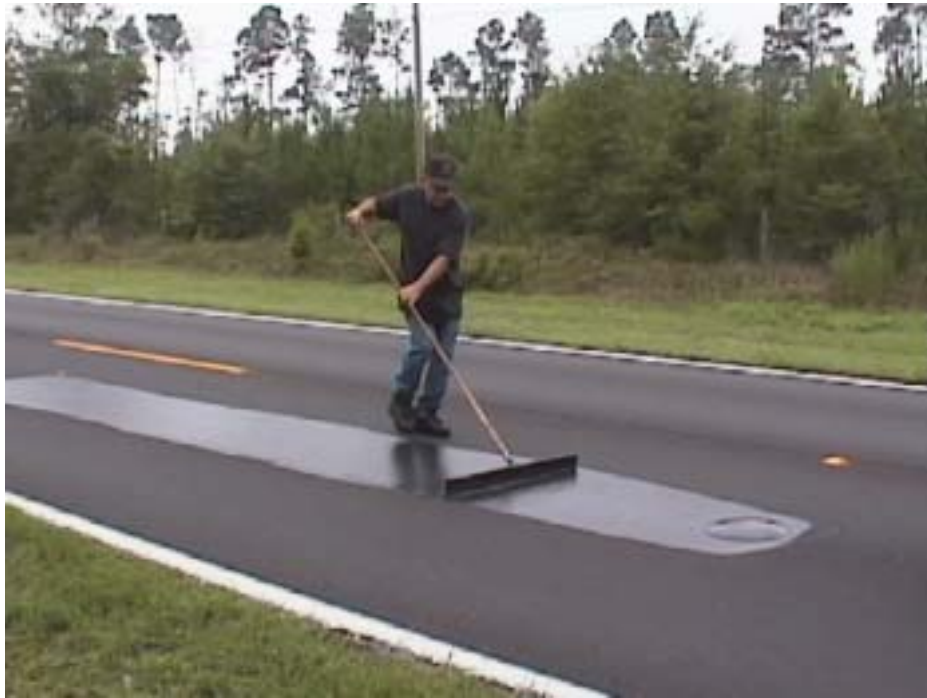
Figure 3-7. Application of Seal Coating with Rubber Squeegee at SR 121

Photos of seal coating application with rubber squeegee at SR 121 and the result with two-coat application at SR 121 are shown in Figure 3-7 and in Figure 3-8 respectively.

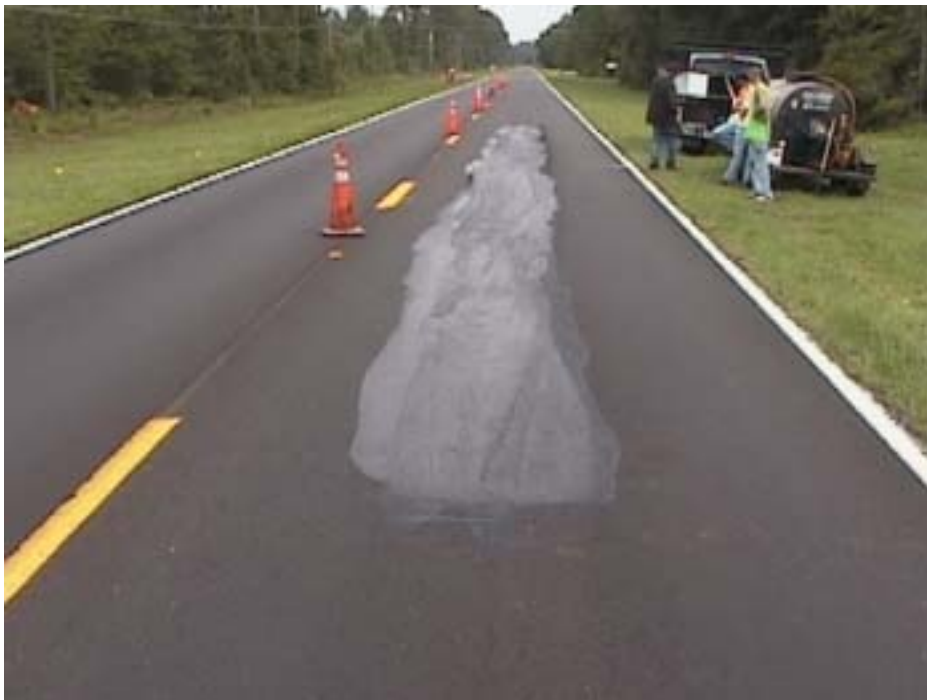
Figure 3-8. Result with Two-Coat Application at SR 121

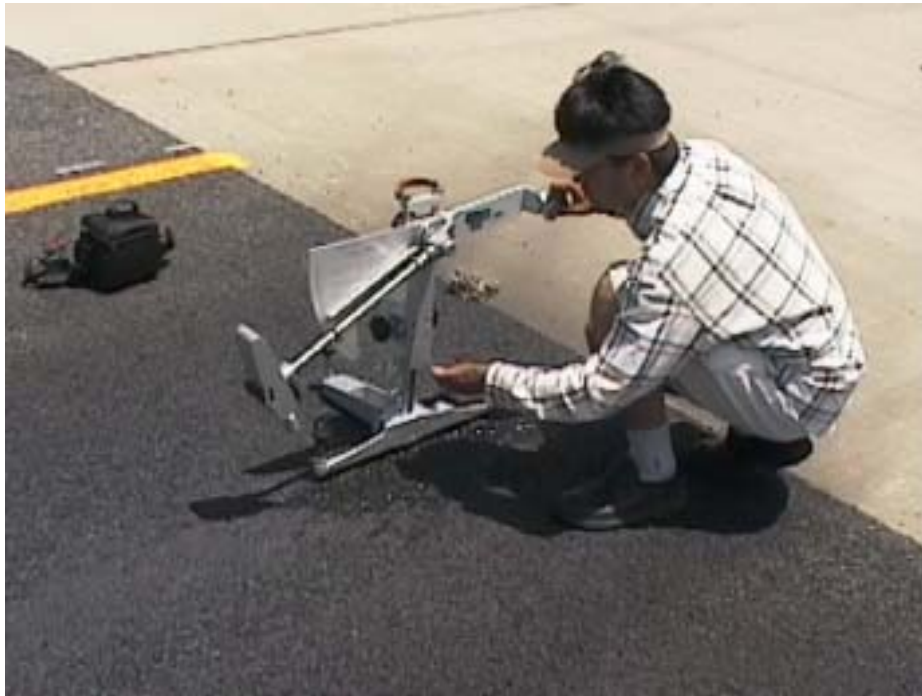
Figure 3-9. The British Pendulum Test at Camp Blanding

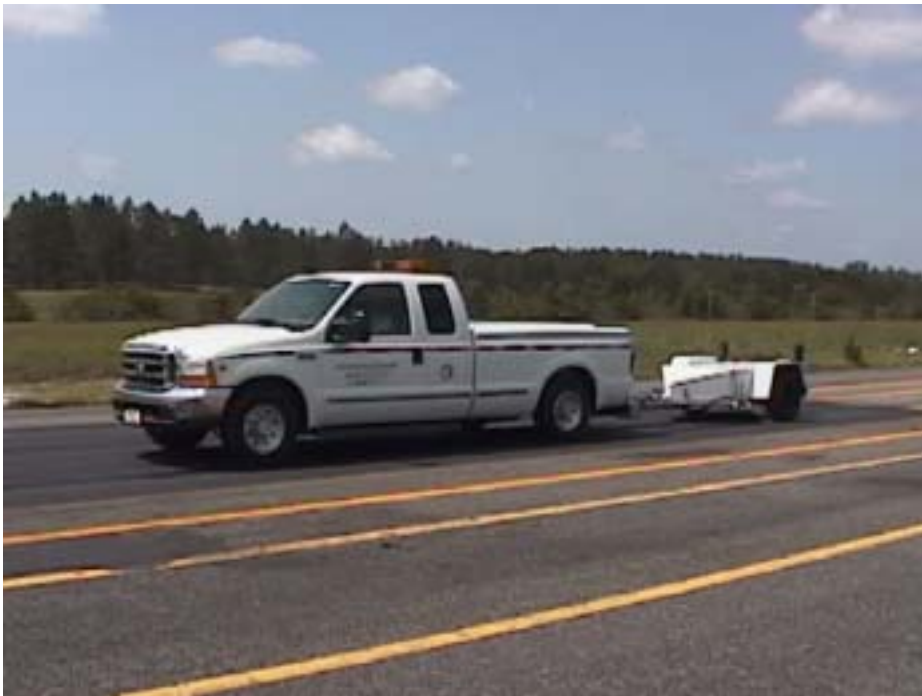
Figure 3-10. Friction Testing by the FDOT Pavement Friction Unit at Camp Blanding

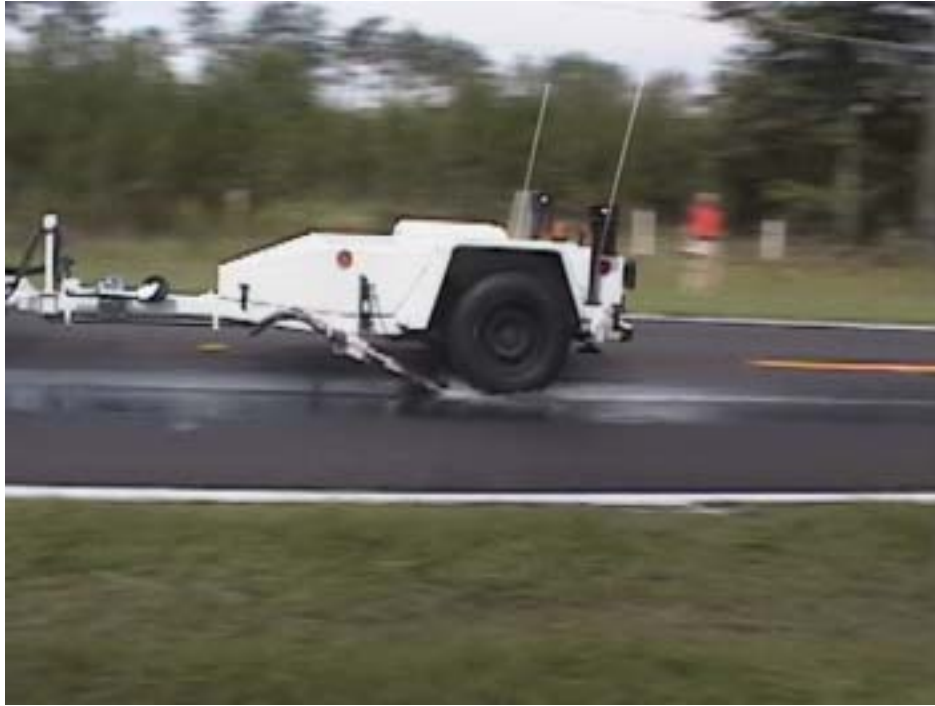
Figure 3-11. Friction Testing by the FDOT Pavement Friction Unit at SR 121

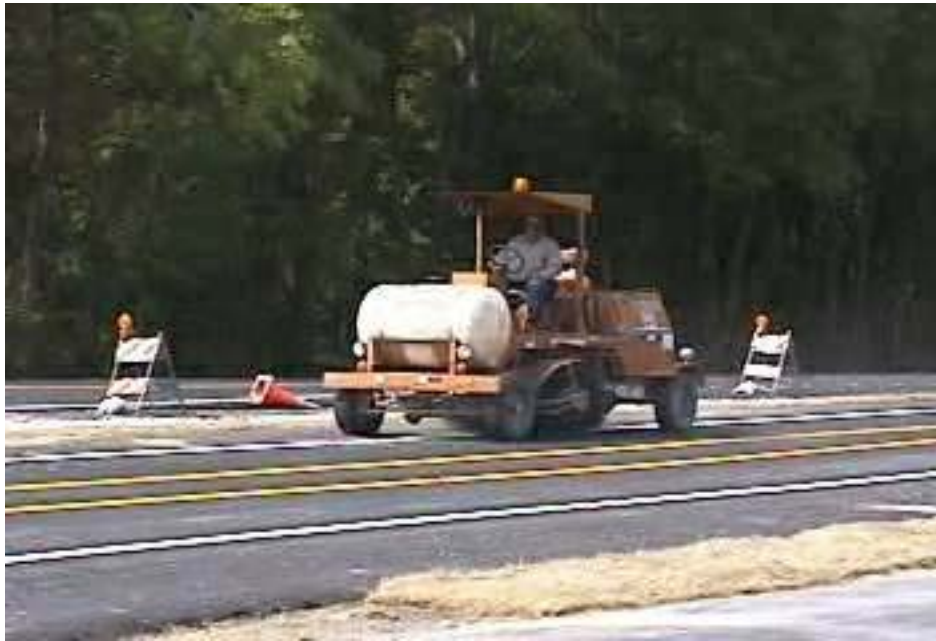
Figure 3-17. Photograph Showing Brooming of the Site Prior to Covering

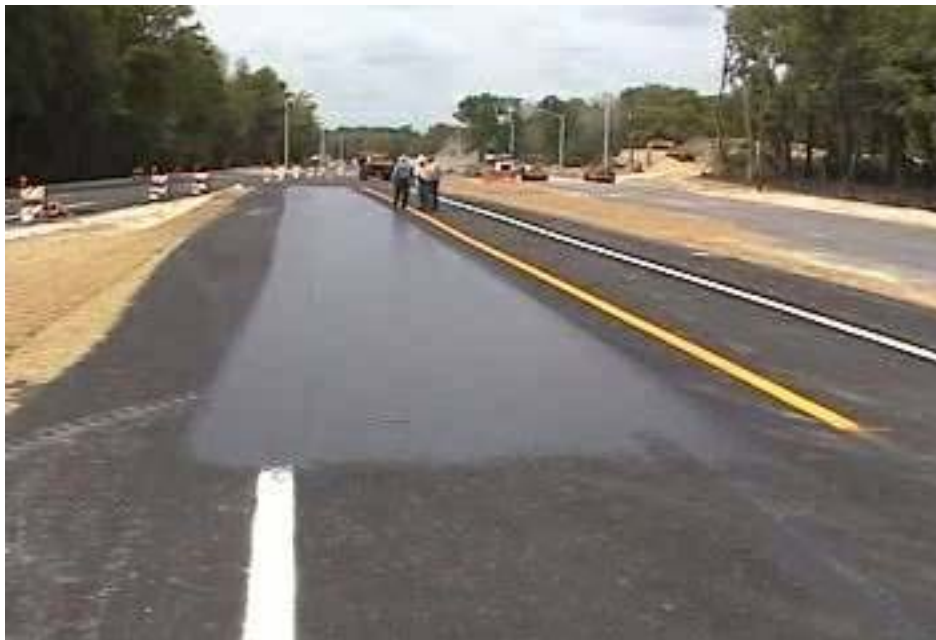
Figure 3-18. Photograph of First Lane After Asphalt Application

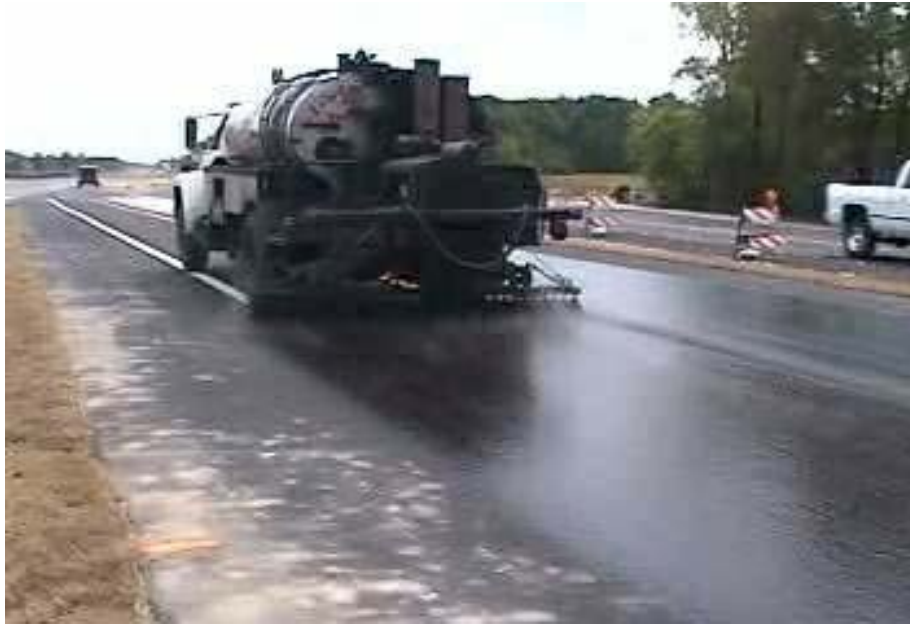
Figure 3-19. Photograph of Second Lane Asphalt Application

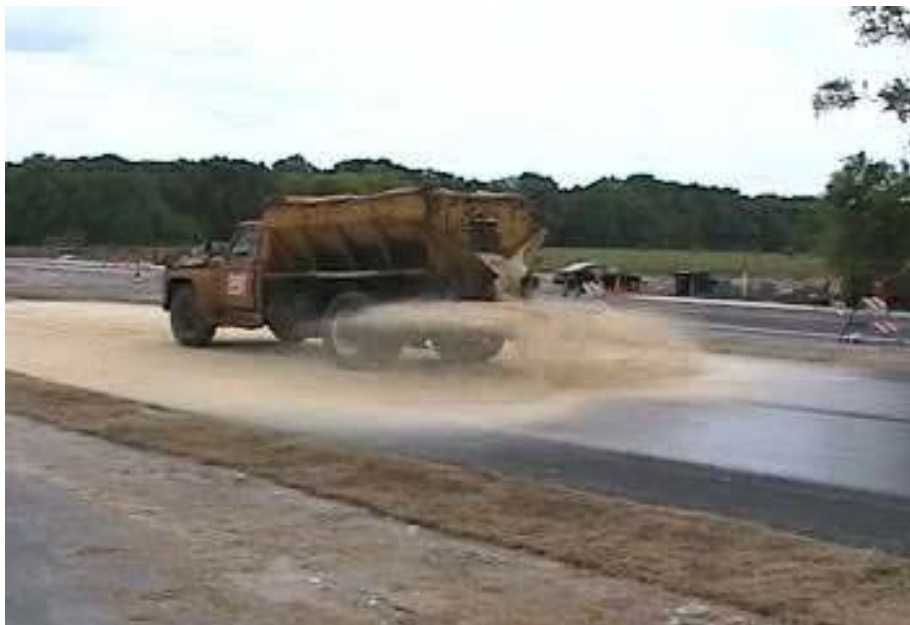
Figure 3-20. Photograph of Sand Application

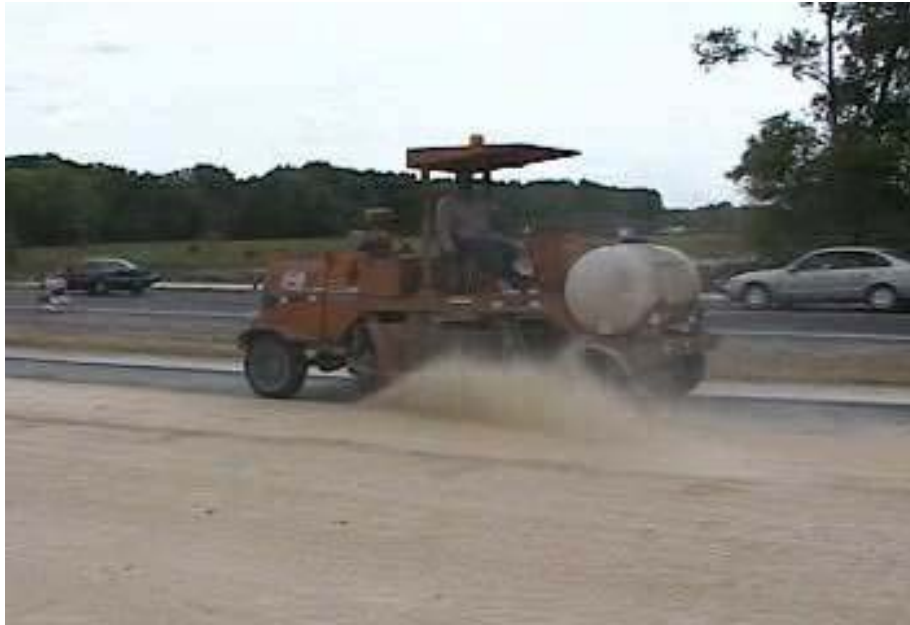
Figure 3-21. Photograph of Brooming After Sand Application

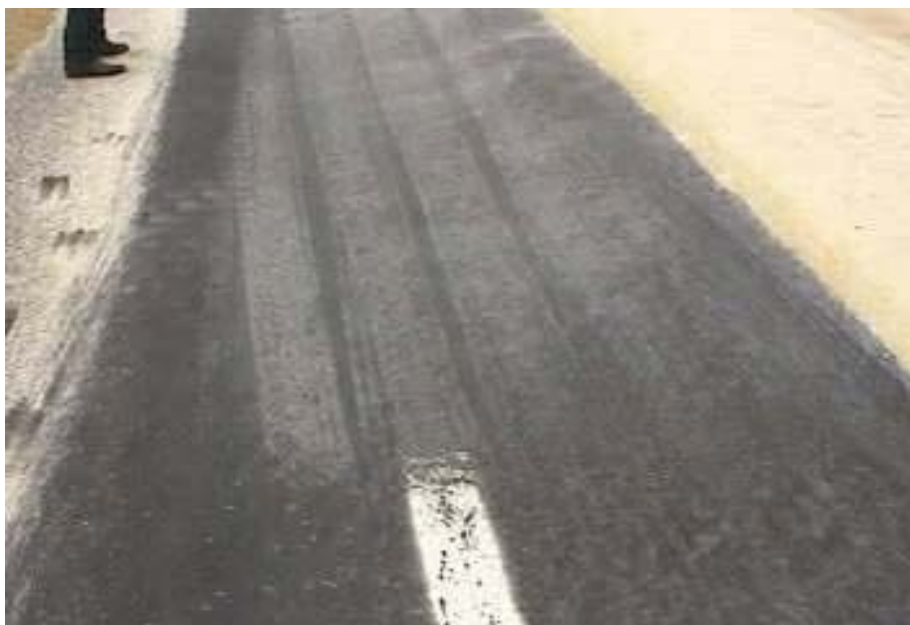
Figure 3-22. Photograph of Pavement After Brooming Sand Off

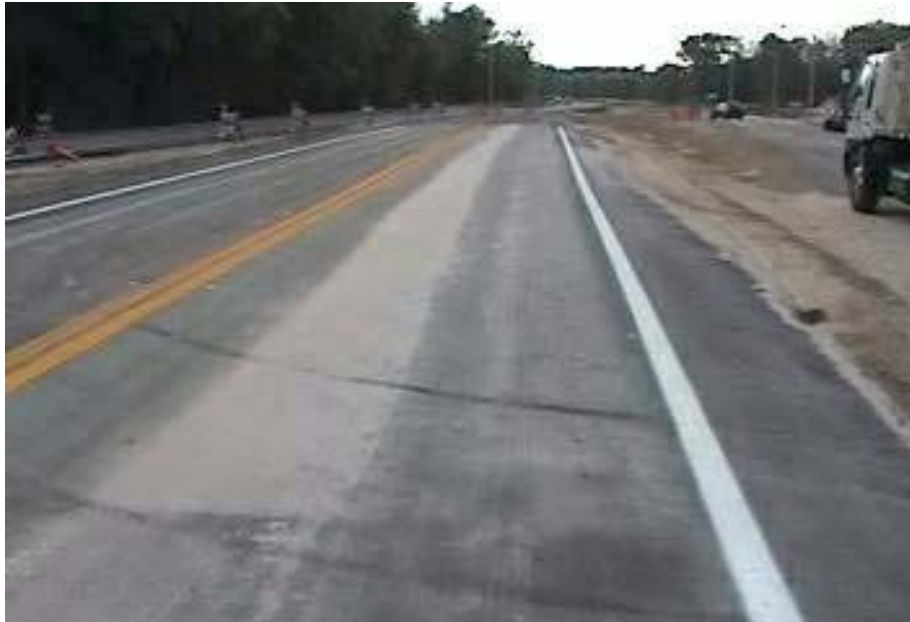
Figure 3-23. Photograph of Test Section Pavement After Sand Seal Application

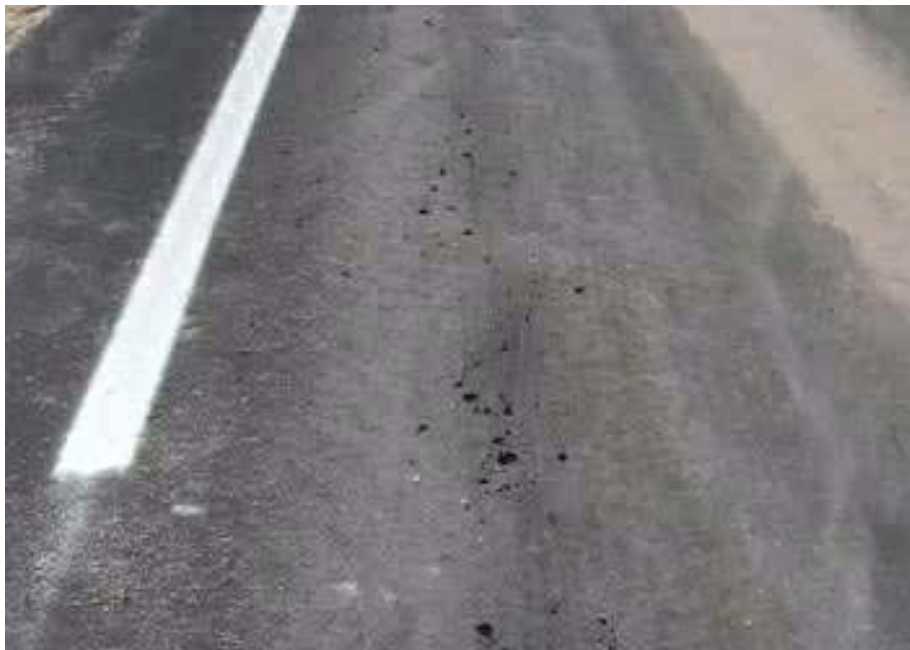
Figure 3-24. Photograph Close Up of Pavement After Sand Seal Application

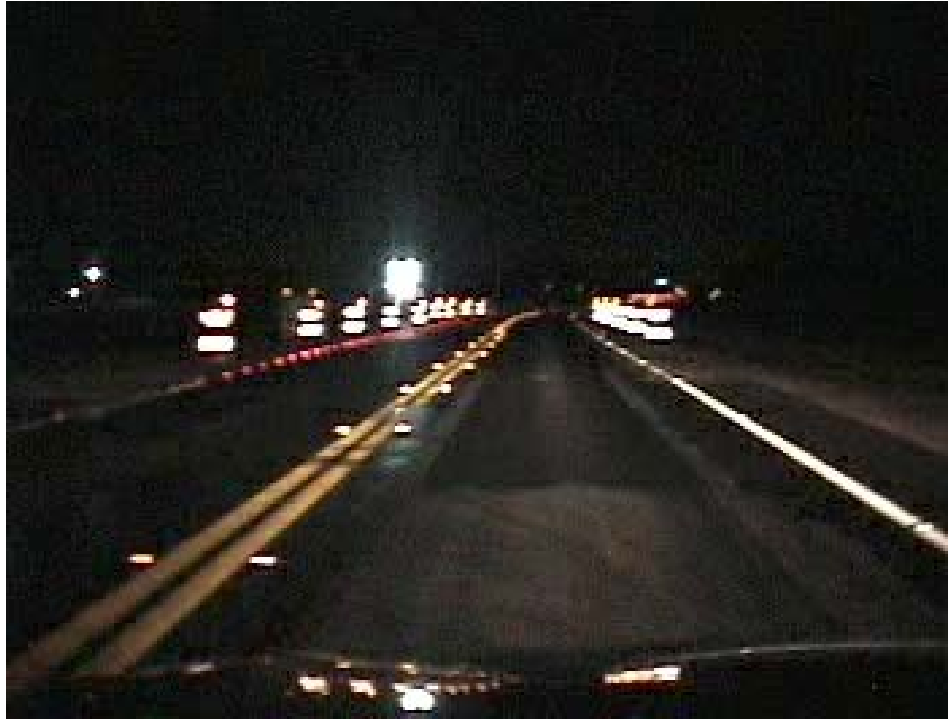
Figure 3-25. Photograph of Test Section Taken at Night with Vehicle Headlights Dry  
Pavement

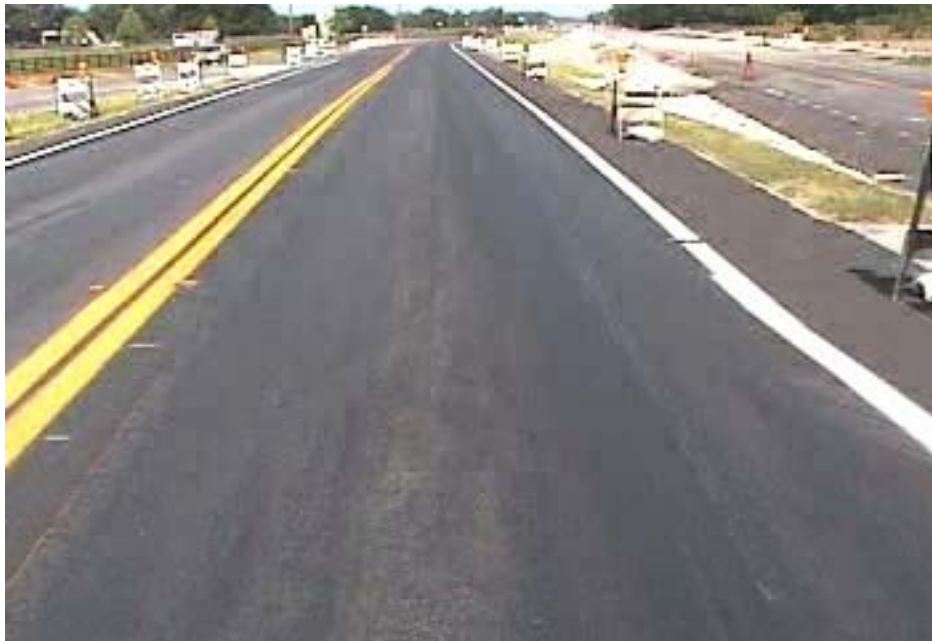
Figure 3-26. Photograph of SR 26 Eastbound (May 1, 2003)

Durability of sand seal was measured by observation of the Sand Seal under traffic conditions. The sand seal installation was inspected on 1, 2003 at which point the installation had been subject to 30 days of traffic. The seal coating was found to be in good condition with no markings visible. Figures 3-26 and 3-27 are photos showing the condition of the Sand Seal Coating after approximately 30 days of traffic. The reported AADT for SR 26 is 48,000 (two-way).

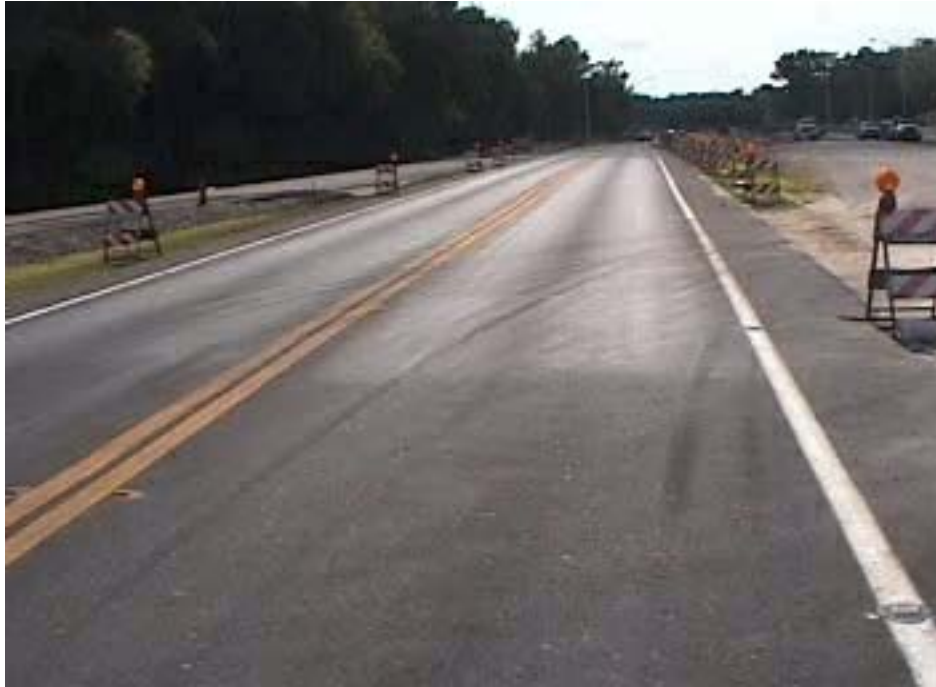
Figure 3-27. Photograph of SR 26 Eastbound (May 1, 2003)

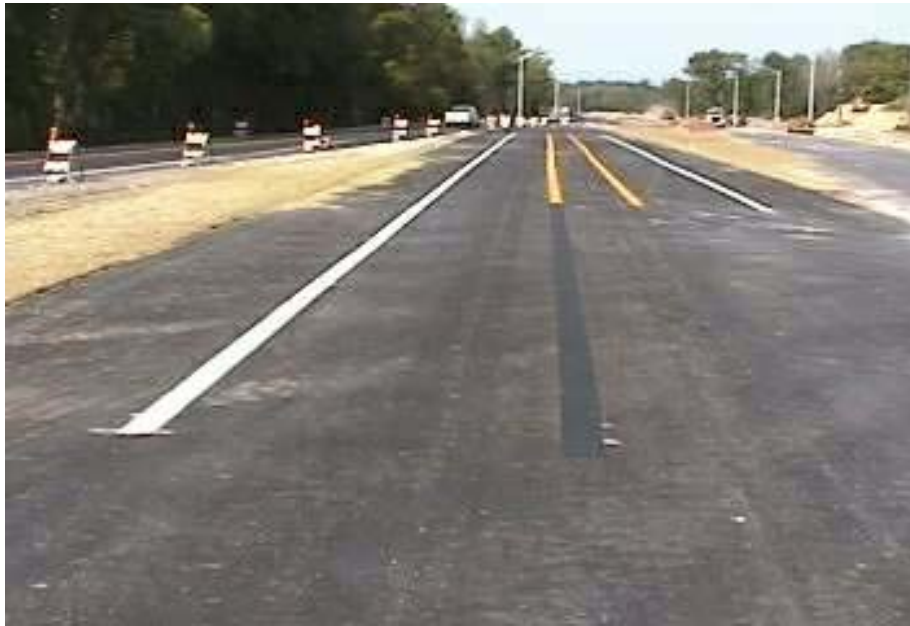
Figure 3-28. Photograph Showing the 3M Removable Black Line Mask Tape

3M marking covering tape (8 inch width) was applied to one of the 40ft. line extensions. The tape was applied in accordance with the manufacture's directions. A similar tape material from Advance Traffic Markings (6 inch width) was installed on the other 40ft. extension on March 28, 2003. Photos of Installation of the 3M Removable Black Line Mask Tape and the ATM Removable Polymer Tape are shown in Figure 3-28 and Figure 3-29. A Photograph Showing the consolidation of the tape with a Vehicle Tire is shown in Figure 3-30. Note that the temporary marking lines were slightly over sprayed and the

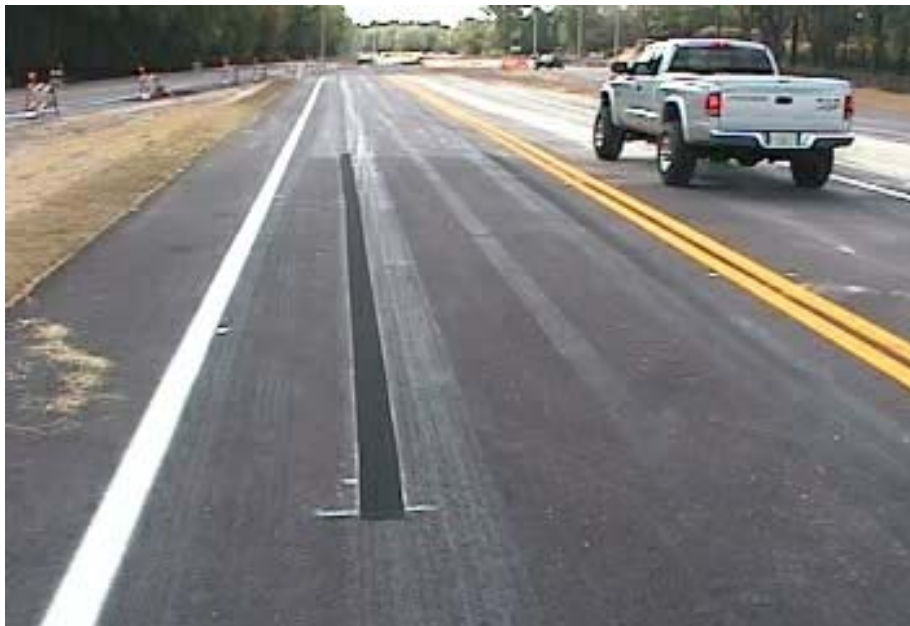
Figure 3-29. Photograph of Installation of ATM Removable Polymer Tape

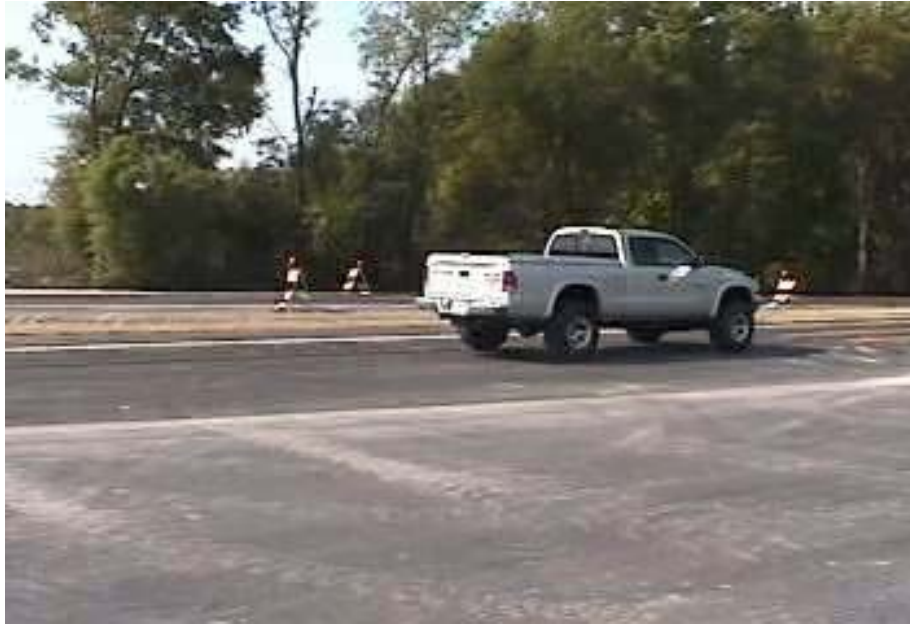
Figure 3-30. Photograph Showing the Consolidation of the Tape with a Vehicle Tire

Installation of both tape products required two people and about 10minutes each. The tapes were consolidated with a vehicle tire. However, the manufactures also suggest using a small roller. The color of the tapes was a dark black and adequately matched the color of the new asphalt. Observations of the pavement section at night under dry conditions with vehicle headlights indicated that both tapes matched the pavement and were not distinguishable as lines.

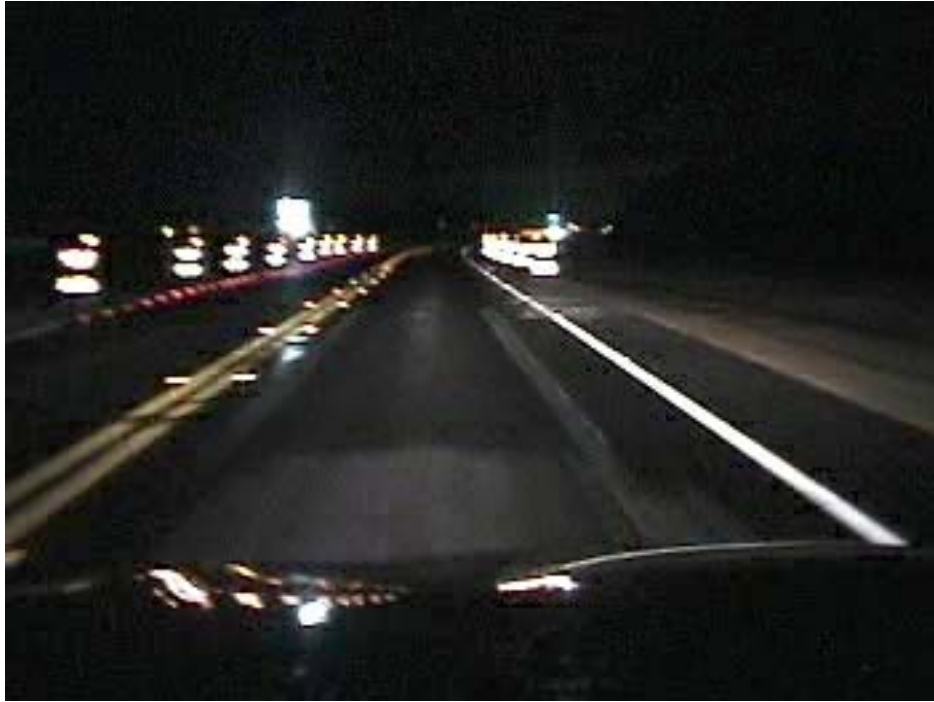
Figure 3-31. Photograph of Test Section Taken at Night from Vehicle with Headlights

Wet Pavement

Reflectivity of the Tapes was measured by observation of the Covering Tapes Under Wet Conditions. According to researcher's observation, the reflectivity of both tapes does not affect drivers. Figure 3-31 is a photo of a motorist view of the taped section under wet pavement conditions. The tape installation was inspected on April 30, 2003 at which point the installation had been subject to 30 days of traffic. The tapping was found to be in good condition with no markings visible.
